# FINAL REPORT TR-NAVFAC-EXWC-EV-1404

In-Situ Shipboard Heat Exchanger Cleaning and Maintenance Using Innovative I<sub>2</sub> Bubble Infusion Technology

**ESTCP Project WP - 201219**

July 15, 2014

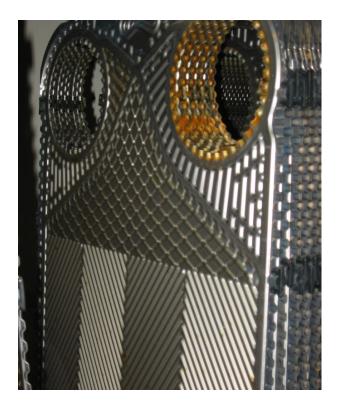
Figure 2.6 HX Plate Surface after I<sub>2</sub>CP

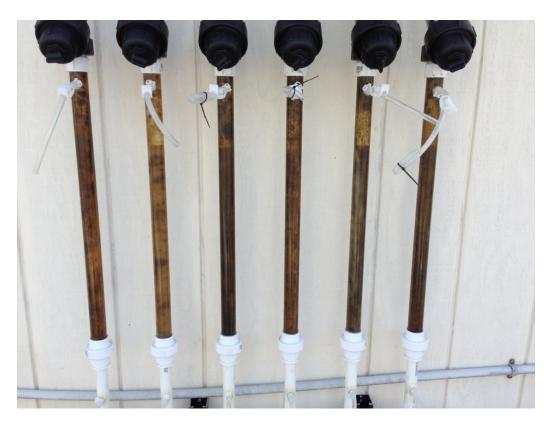
Figure 6.1 Algae Growth in Outside Infused Tube

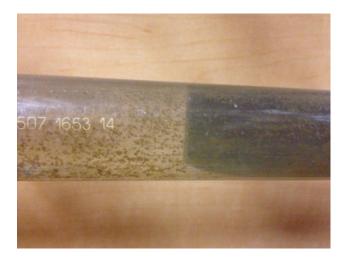
Figure 6.2 Bio-fouling in Indoor Un-infused Tube

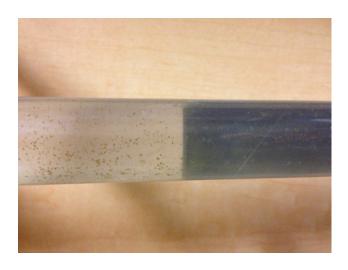
Figure 6.3 Bio-fouling in Indoor Infused Tube

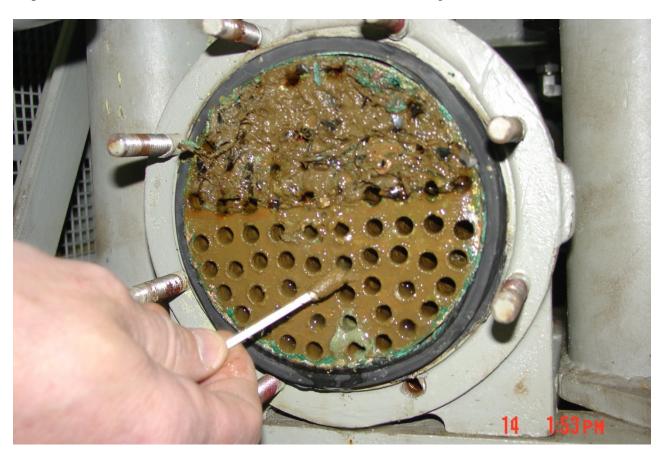
At the end of the demonstration, but prior to the final cleaning, the ship's crew removed the exchangers head for observation by the demonstration team. Figures 6.6, 6.7, and 6.8 show significant sea grass and mud in LPAC No. 1, but little biological fouling. Similar results were found for LPAC No. 2. The heat exchangers are designed to allow water flow from the top half of the tube bundle into a curved faceplate and then through the bottom. This is why the sea grass only presented in the top half. While both exchangers were disassembled, the project team inspected several of the HX tubes and found little solidified fouling.

Figure 6.6 LPAC No. 1 HX Tubes Prior to Removing Sea Grass

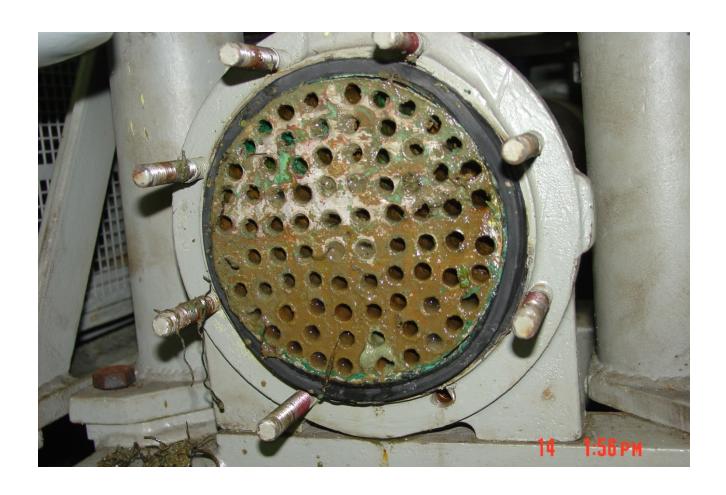
Figure 6.7 LPAC No. 1 HX Tubes After Removing Sea Grass

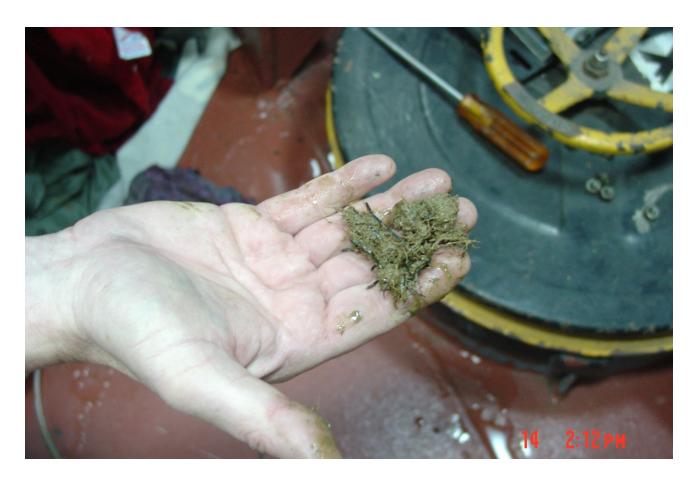
Figure 6.8 LPAC No. 1 Sea Grass
